Manhole Inspection Summary

Manhole # S29II_031MH

Location Address: **1532 MCMECHEN ST**

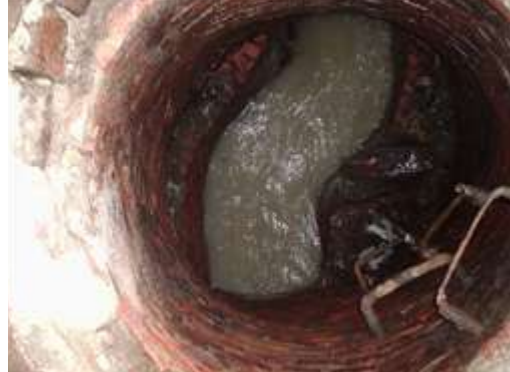
Top View

Corroded steps. Evidence of surcharge - Bench debris.

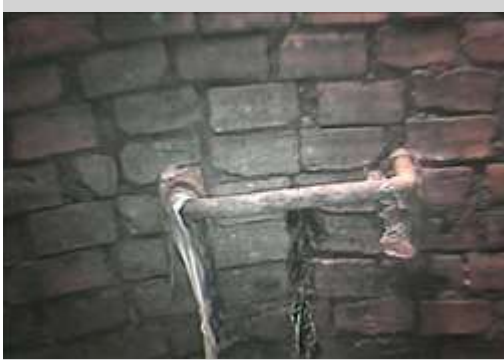
Evidence of surcharge

Barrel deterioration and infiltration.

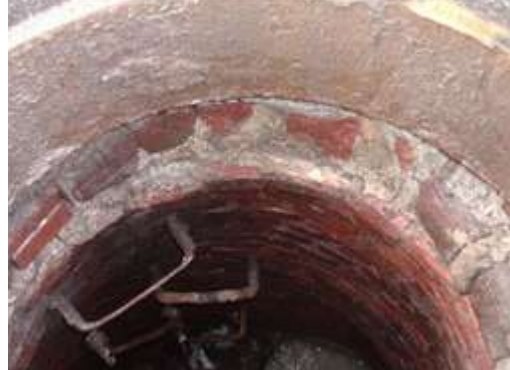
Defect

Frame leaks. Adjustment deterioration and infiltration. Corbel and Barrel infiltration.

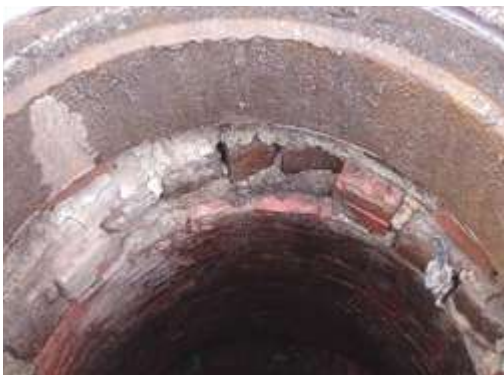
Defect

Frame leaks. Adjustment deterioration and infiltration. Corbel and Barrel infiltration - other side.

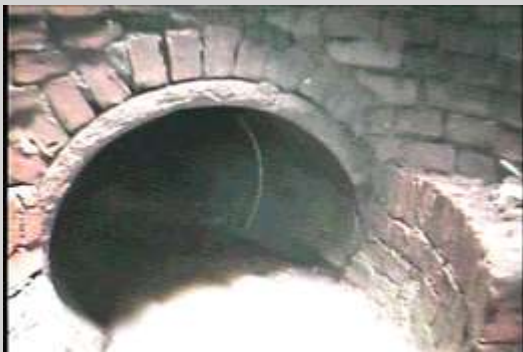
24 in. Circular Gravity Sewer Pipe Out @ 12 O'Clock

Infiltration: **Evidence** Pipe Seal Cond: **Unknown**

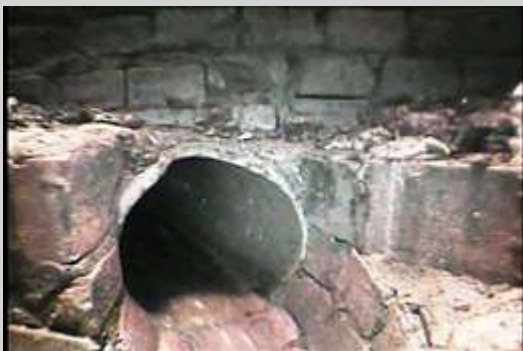
8 in. Circular Gravity Sewer Pipe In @ 3 O'Clock

Channel deterioration.

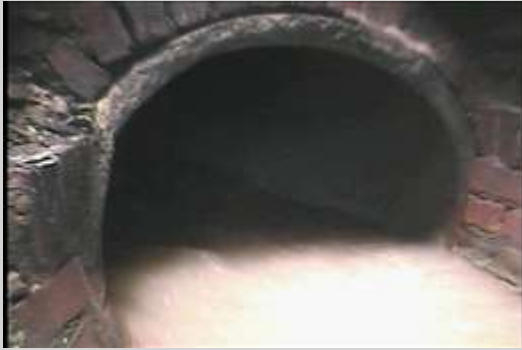
Pipe In @ 6 O'Clock

Infiltration: **Evidence**
